Emergency Vehicle Access During Flooding

An Inventory of Major Roadways in
Eastern Pima County and the
Relative Risk to Motorists Driving
During Relatively, Small Frequent Floods

Contract No.: 16-04-A-130075-1001,
As-Needed Flood Plain Management Services

ARROYO ENGINEERING, INC.
5675 North Oracle Road
Tucson, Arizona 85704
(520) 882-0206

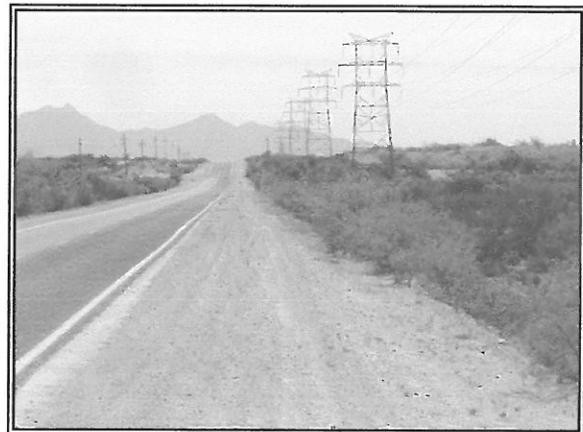
(Houghton Road, near Drexel Road)

Examples of these general roadway classifications are given below in the following photographs. Photograph #1 was taken of Houghton, south of Drexel Road, and it shows an elevated roadway that freely drains away from the roadway.

Photograph 1. Passable During Major Storms

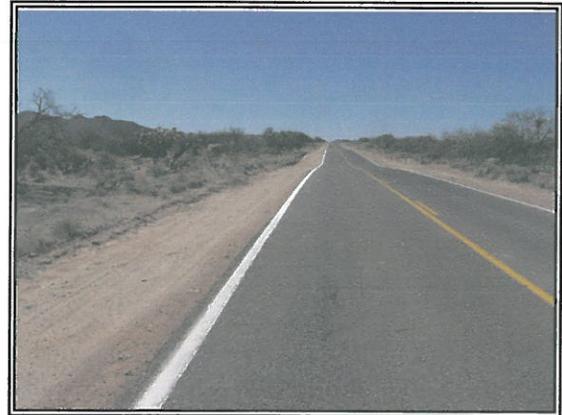
Photograph #2 was taken of Sierrita Mountain Road, south of Ajo Way, and it shows a roadway that has occasional at-grade wash crossings, but is otherwise free from cross drainage. Photograph #3 was taken of Camino Verde, near Bopp Road, and it shows a roadway that intercepts and convey sheetflow along the roadway shoulder.

Photograph 2. Passable During Moderate Storms
(Sierrita Mountain Road, south of Ajo Way)

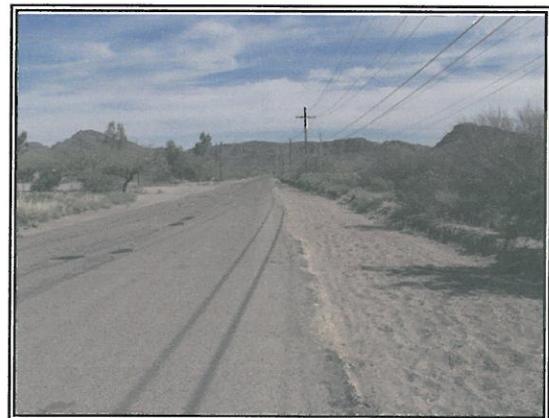
Photograph 3. Questionable During All Storms
(Camino Verde, near Bopp Road)
